Manhole Inspection Summary

Manhole # S37W__011MH

Insp Date: **3/5/09 11:43 AM**

Location Address: **1705 byrd st**

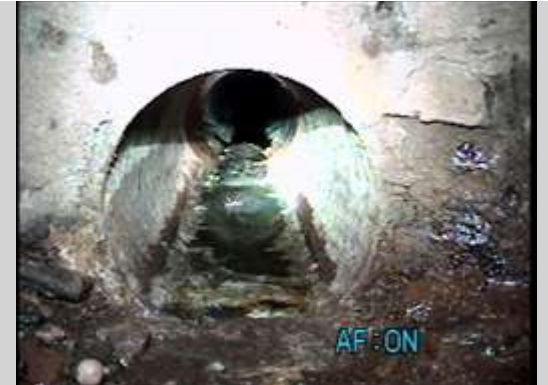
12 O'Clock Outflow

8 in. Circular Gravity Sewer
Pipe Out @ 12 O'Clock

Infiltration: **None** Pipe Seal Cond: **Unknown**
